National Transportation Safety Board Aviation Accident Preliminary Report

Location:	New Washoe City, NV	Accident Number:	WPR18FA247
Date & Time:	09/02/2018, 1335 PDT	Registration:	N22XC
Aircraft:	Schempp Hirth DUO DISCUS T	Injuries:	2 Fatal
Flight Conducted Under:	Part 91: General Aviation - Personal

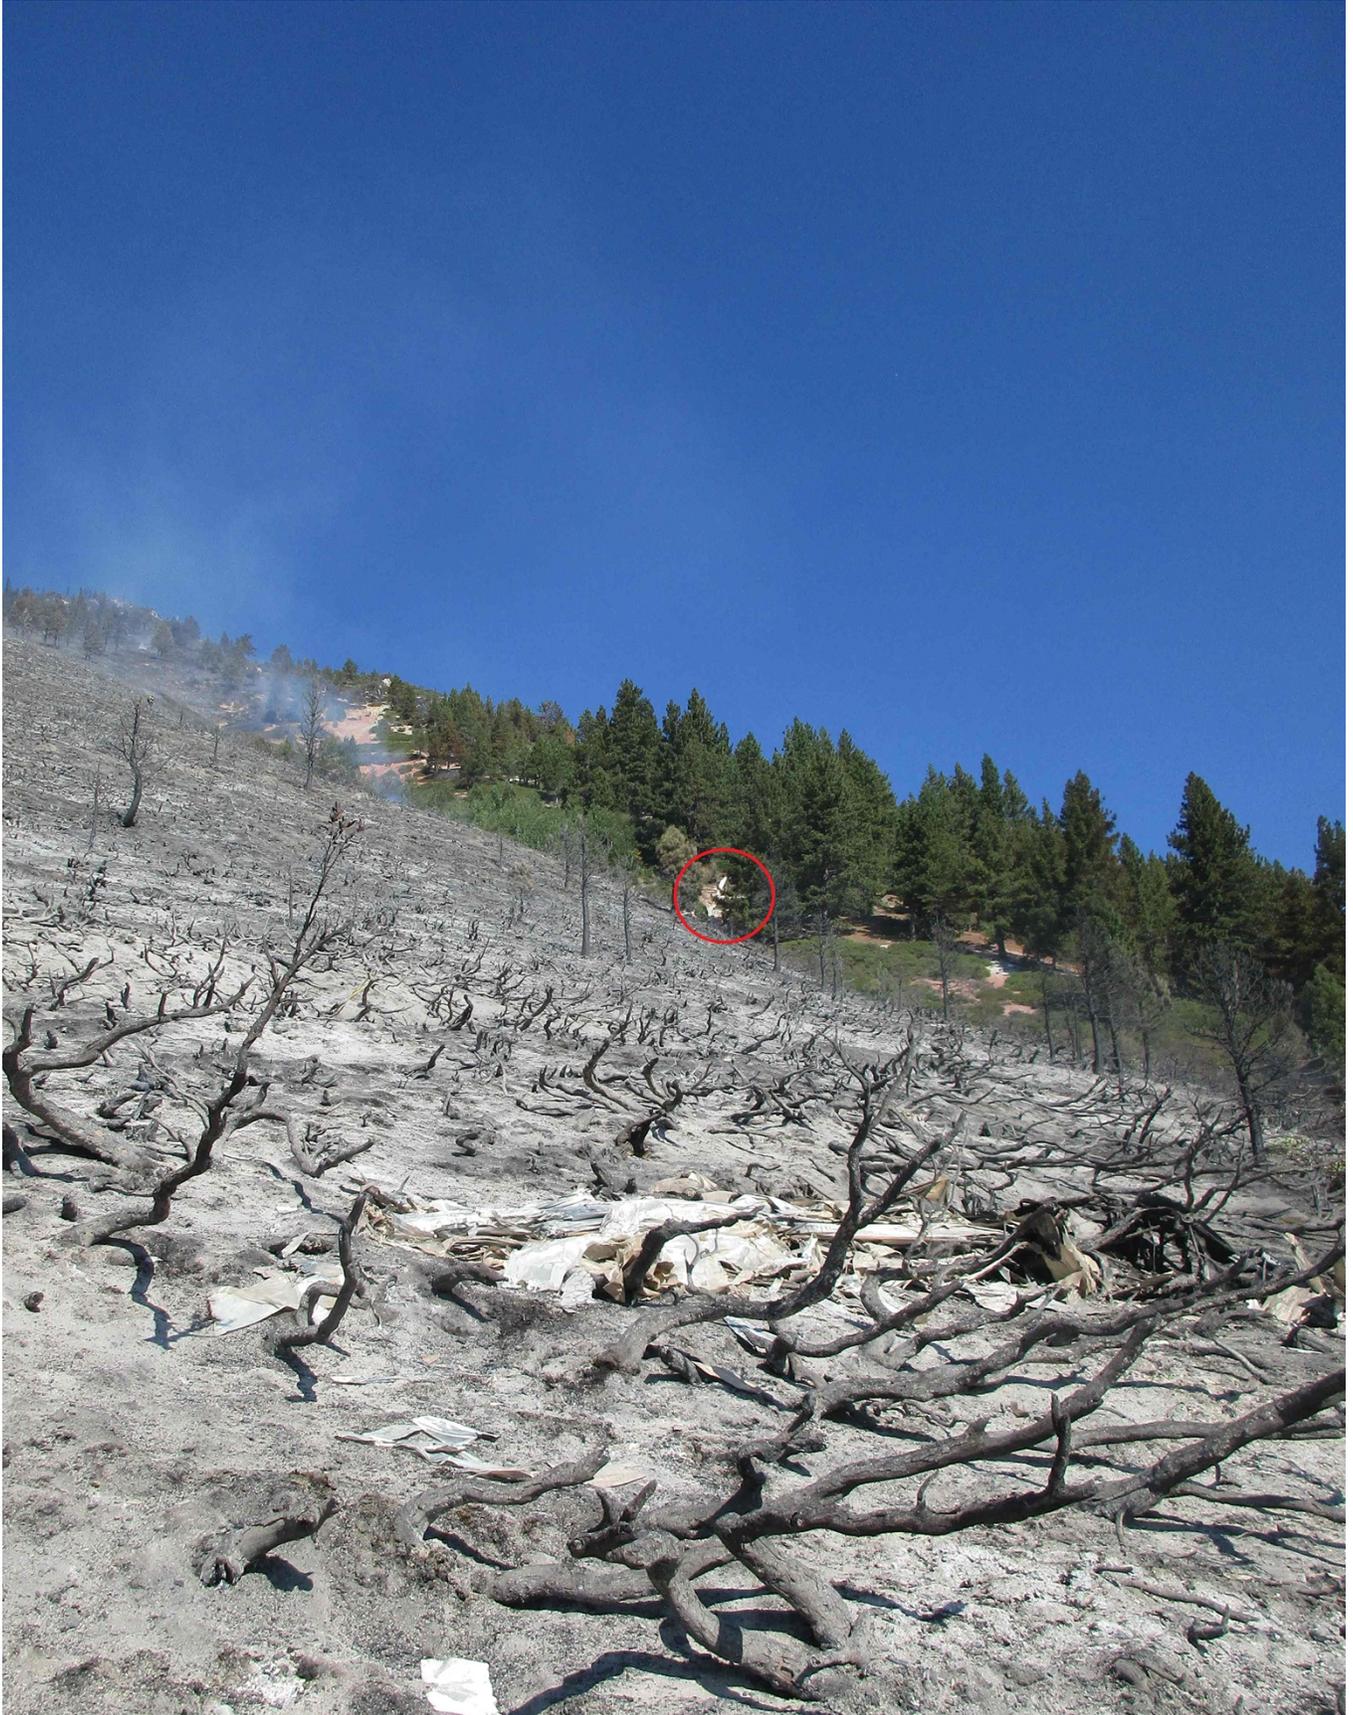
The wreckage was located on the lower eastern flank of Slide Mountain, at an elevation of 6,630 ft, about 2.5 miles east-southeast of the last FLARM-recorded position. The glider ignited a fire upon impact, which eventually burned a 58-acre swath of brush uphill to the west. The main wreckage consisted of the cockpit, engine assembly, wing and vertical stabilizer fragments, all of which were consumed by fire. A secondary 1,500-ft-long debris field emanated northwest from the main wreckage, outside of the burn area, and contained a headrest and a left wing section, along with canopy and control surface fragments.

Photo 1 - Main Wreckage (foreground), with Left Wing Section Circled
